Fluvial Geomorphic and Habitat Assessment of the South River Watershed Project & the Sediment Best Management Practices Implementation Project

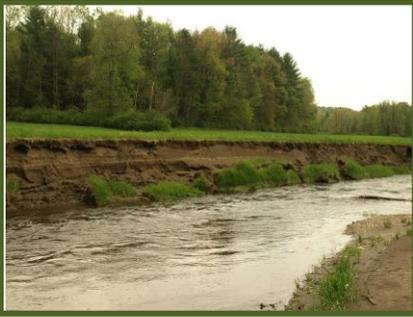
Roads, bridges, farm land and homes have been damaged or are threatened by the major bank erosion occurring in the watershed. Considerable amounts of local, state and federal money have already been spent to repair damaged infrastructure and these repairs are not always successful, as shown in the pictures of the retaining walls on the South River.

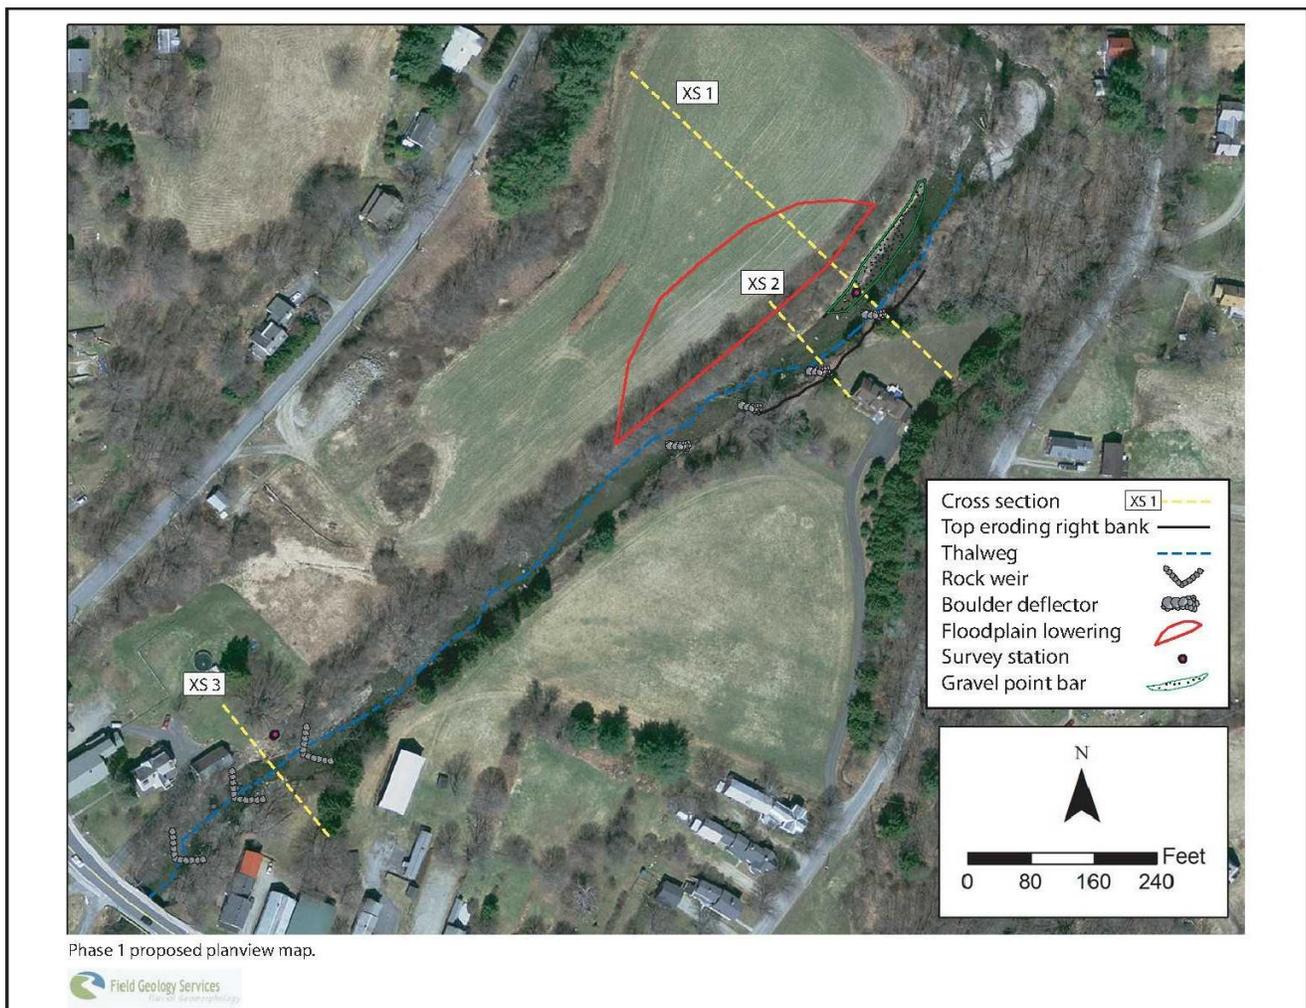
Conceptual restoration plan for the South River downstream of Route 116 Bridge in Conway, MA.
Prepared by Field Geology Services

Bank stabilization will occur in the form of boulder deflectors and V-shaped boulder weirs where residential properties are at risk of erosion. The deflectors and weirs will also improve flow complexity that will lead to pool formation and better particle size segregation. Anchored logs will be placed at the base of the banks between the boulder structures to promote sediment deposition along the now actively eroding banks.

In addition to the bank stabilization, the project includes lowering a section of abandoned floodplain on the Town field property. Reclamation of the once active floodplain will improve sediment storage, especially of problematic fine sediments.¹ Reactivating a portion of the floodplain will also improve the river's geomorphic and habitat function, and lead to a reduction of flood flow velocities and, therefore, downstream sediment transport.
